Manhole Inspection Summary

Manhole # S55M__014MH

Insp Date: **10/27/08 2:37 PM**

Location Address: **3700 odonnell st**

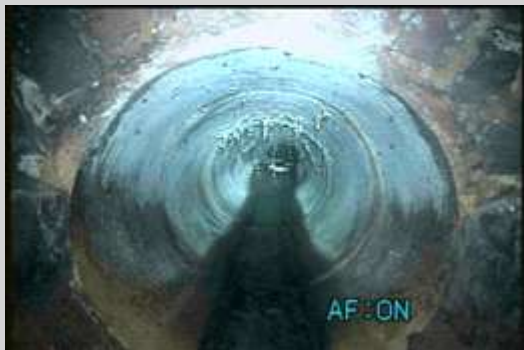
12 O'Clock Outflow

12 in. Circular Gravity Sewer
Pipe Out @ 12 O'Clock

Pipe Material: **Clay** ☐ Pipe Lined

Invert Depth: **9.10** (ft.) Flow Characteristics: **Fast**

Infiltration: **None** Pipe Seal Cond: **Unknown**

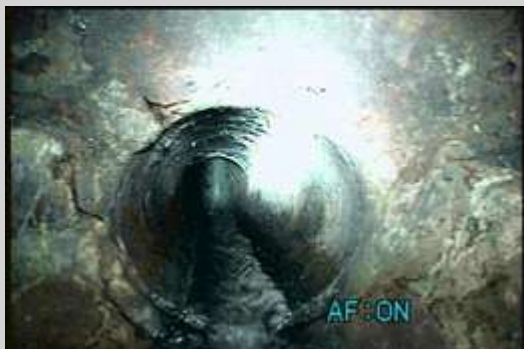
5 O'Clock Inflow

8 in. Circular Gravity Sewer
Pipe In @ 5 O'Clock

Pipe Material: **Clay** ☐ Pipe Lined

Infiltration: **None** Pipe Seal Cond: **Unknown**
